Grooved-in Pavement Markings on Moab Main Street

UDOT Maintenance Methods Study

Ken Berg, P.E. Product Evaluation Engineer

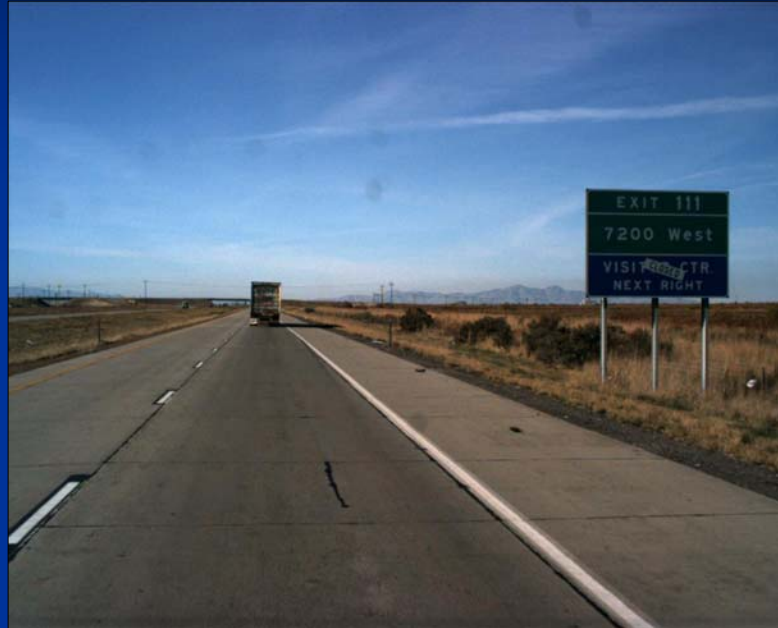
Grooved Waterborne Successful on I-80 shoulders and skips...

- I-80, Salt Lake Valley, west side near Great Salt Lake
 - Concrete Pavement
 - Heavy plowing, high AADT
 - Installed Sept. 2006
 - Still looks good after two winters

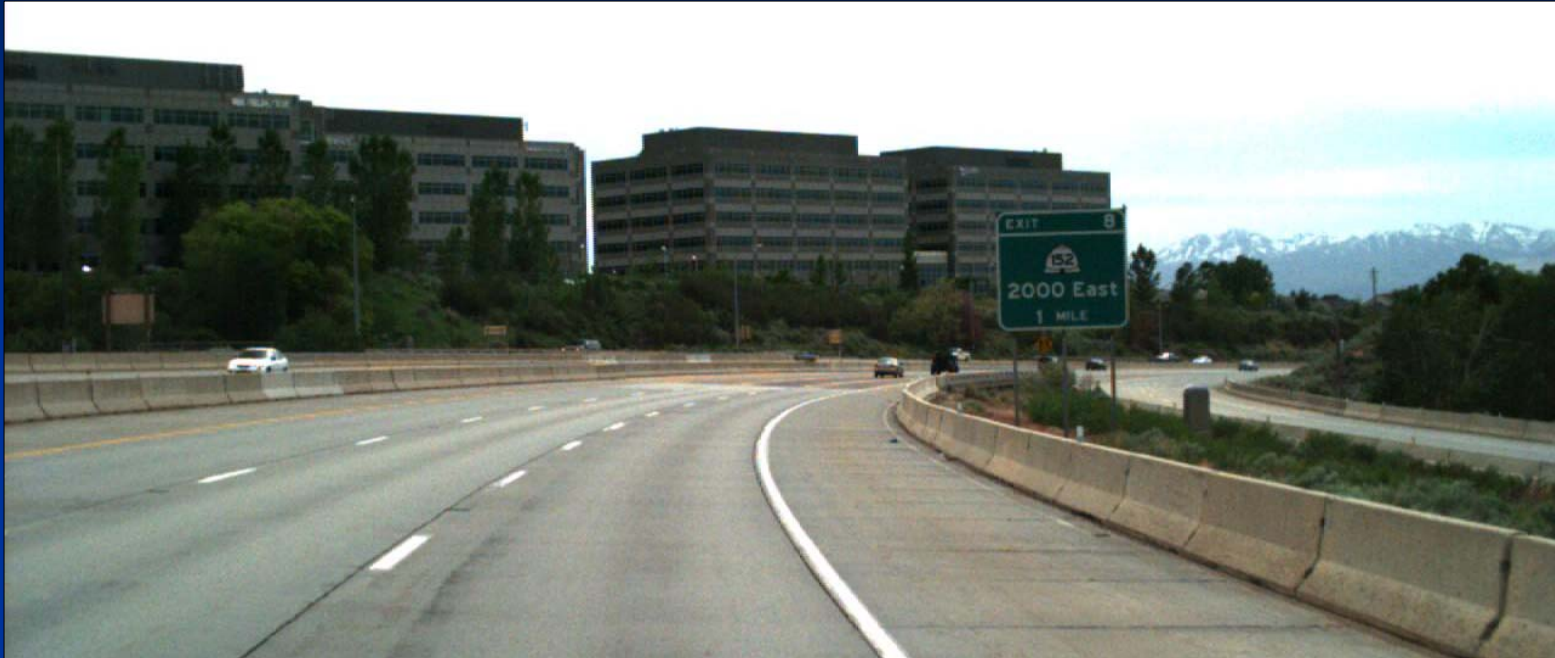
and on I-215 skips...

- I-215, Salt Lake Valley, east bench
 - Concrete pavement
 - Heavy plowing, high AADT
 - Difficult to maintain markings through the winter
 - Installed on skips June 2005 still looked good early spring of 2008

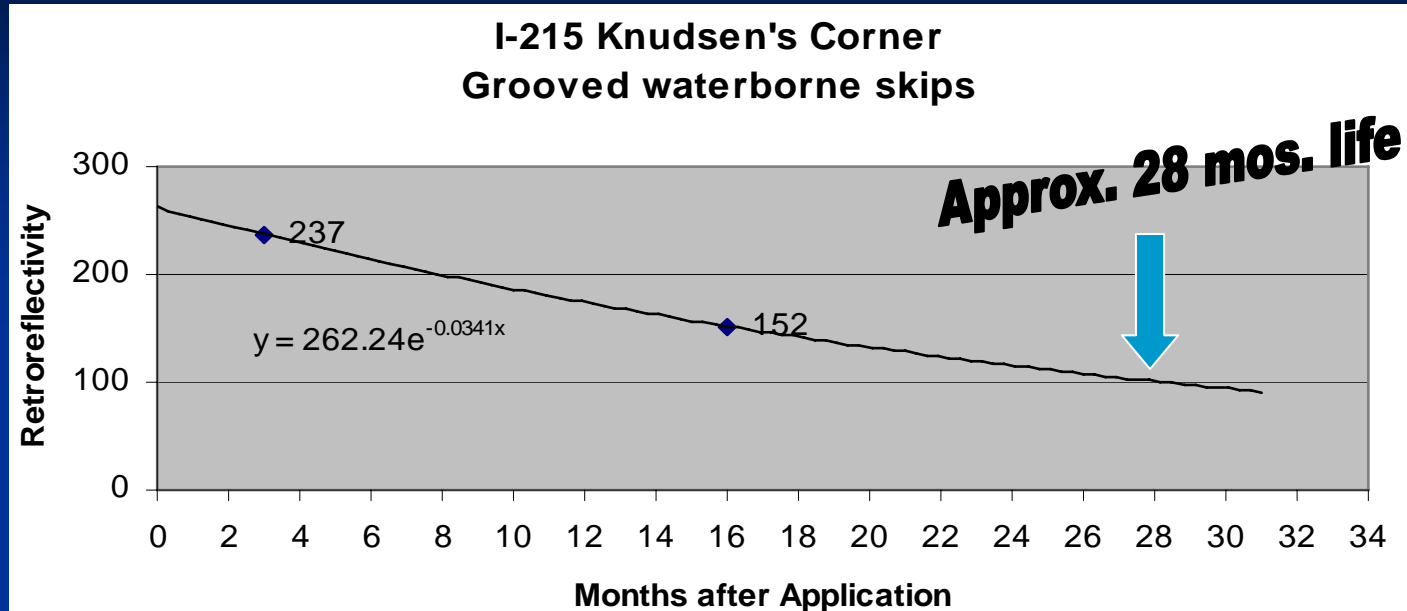
I-215 Life Projection

- Grooved 60 mils in skips
- Applied state spec waterborne
- Mobile retros averaged over all lines for given date
- Good presence after 3 winters

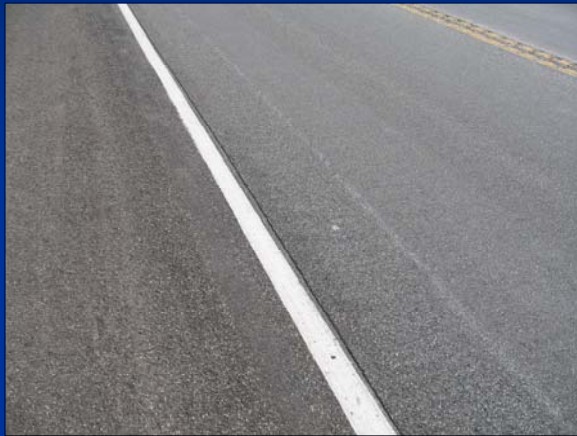
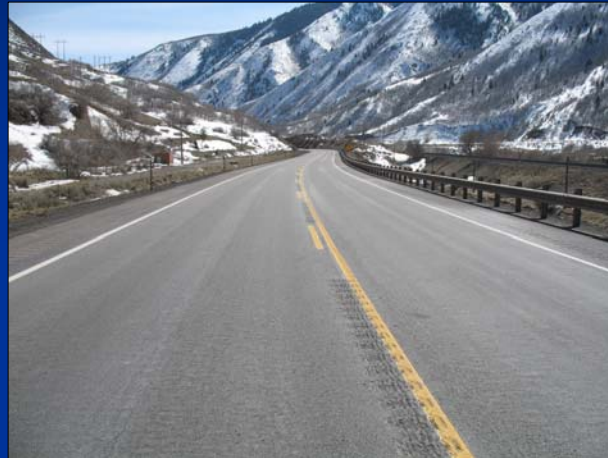
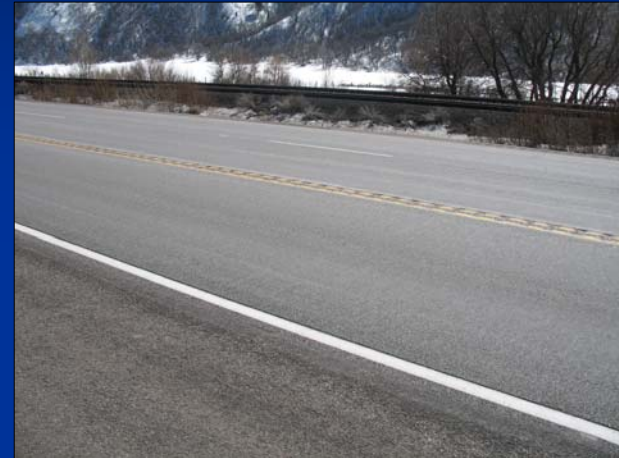
...and SR-6 in Spanish Fork Canyon

- Mouth of Spanish Fork Canyon to Diamond Fork turn-off (7 miles)
 - Installed Sept. 2007 on a new microsurface
 - Pictures taken Mar. 2008—loads goods after a severe winter

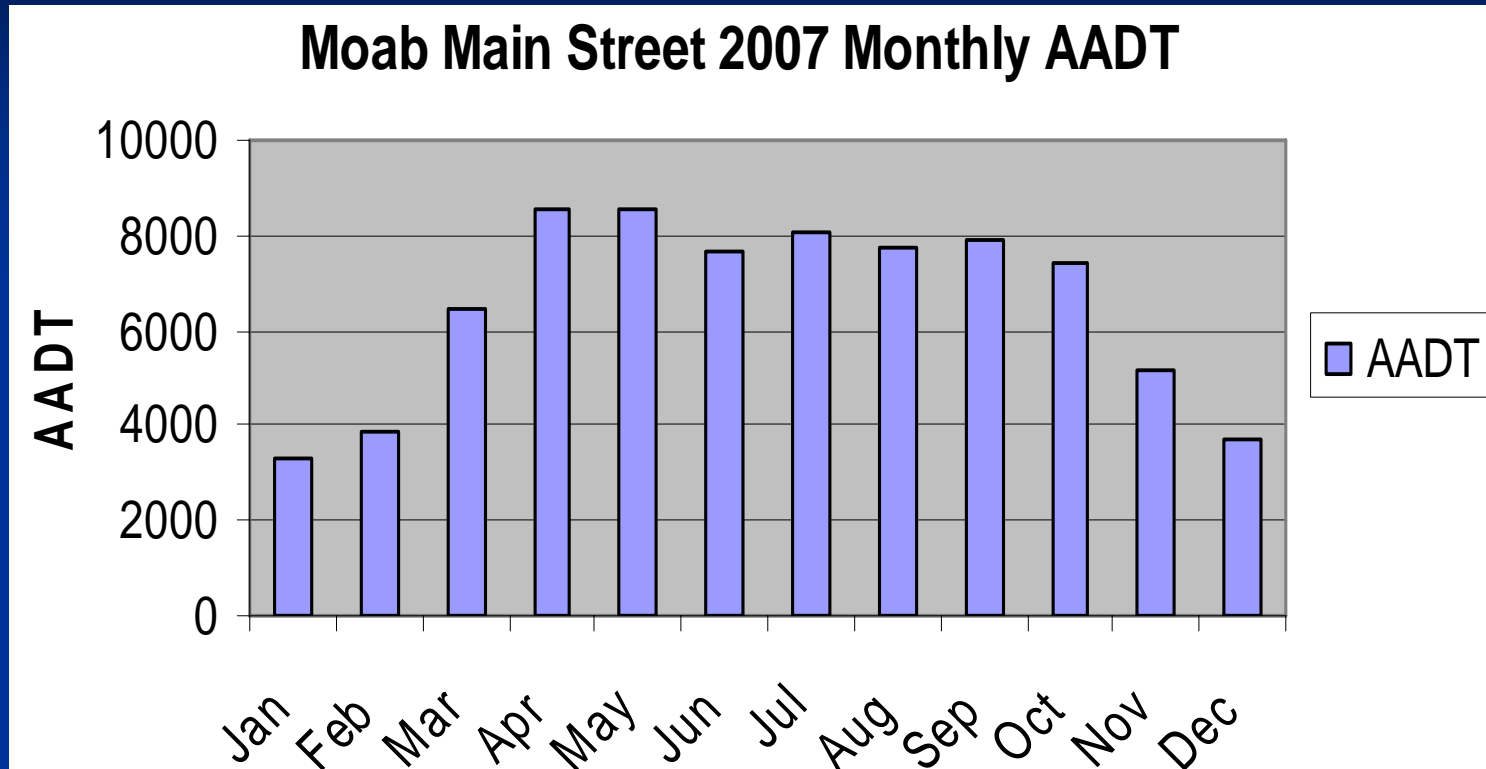
Moab Traffic

- AADT increase during tourist season-Mar. to Oct.
- 32% trucks

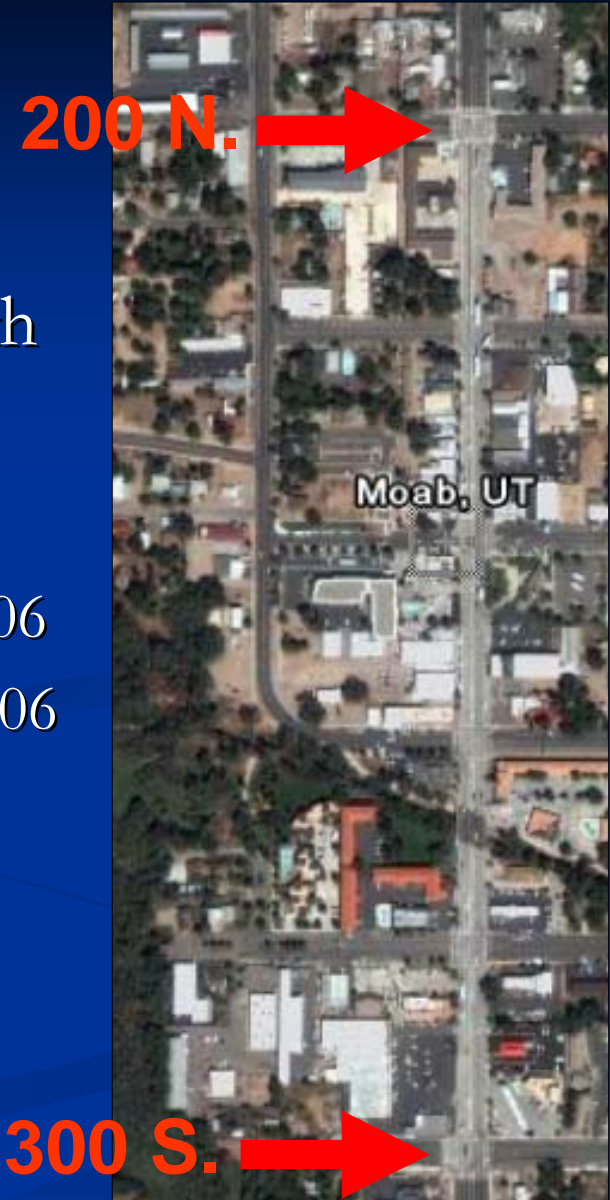
2006 Reconstruction

- 200 North to 300 S., 0.5 miles
- Existing asphalt replaced with full depth PCC
- 2 phases
 - Phase I completed and painted in May 2006
 - Phase II completed and painted in July 2006
- State spec HD-21 Waterborne
 - 2 coats in some locations
 - 20-25 wet mil application
 - Messages and long lines by contractor

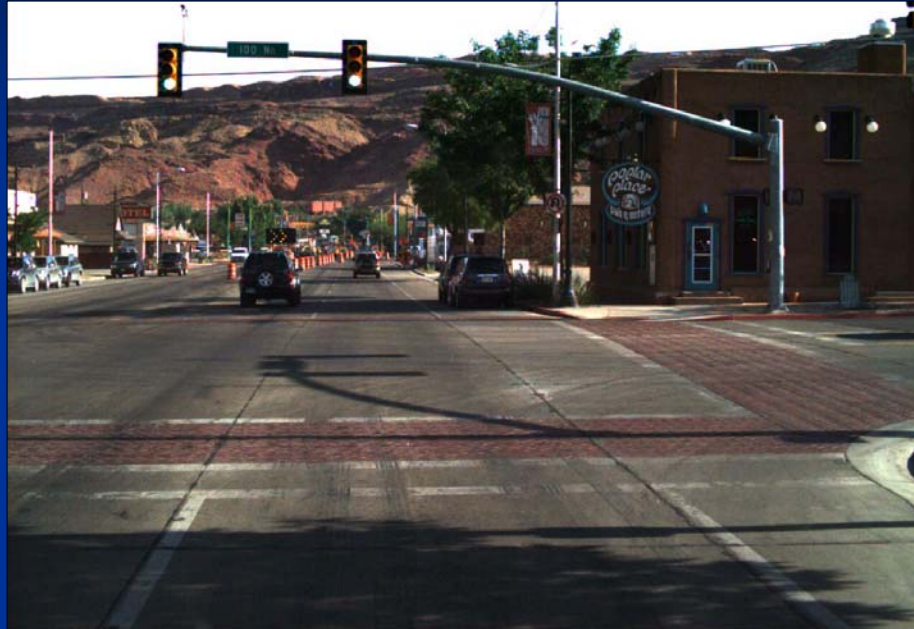
Marking Performance History

- Poor condition after 3 months
- Repainted by contractor when project completed in spring of 2006
- Pavement messages painted again by Price District in June 2007

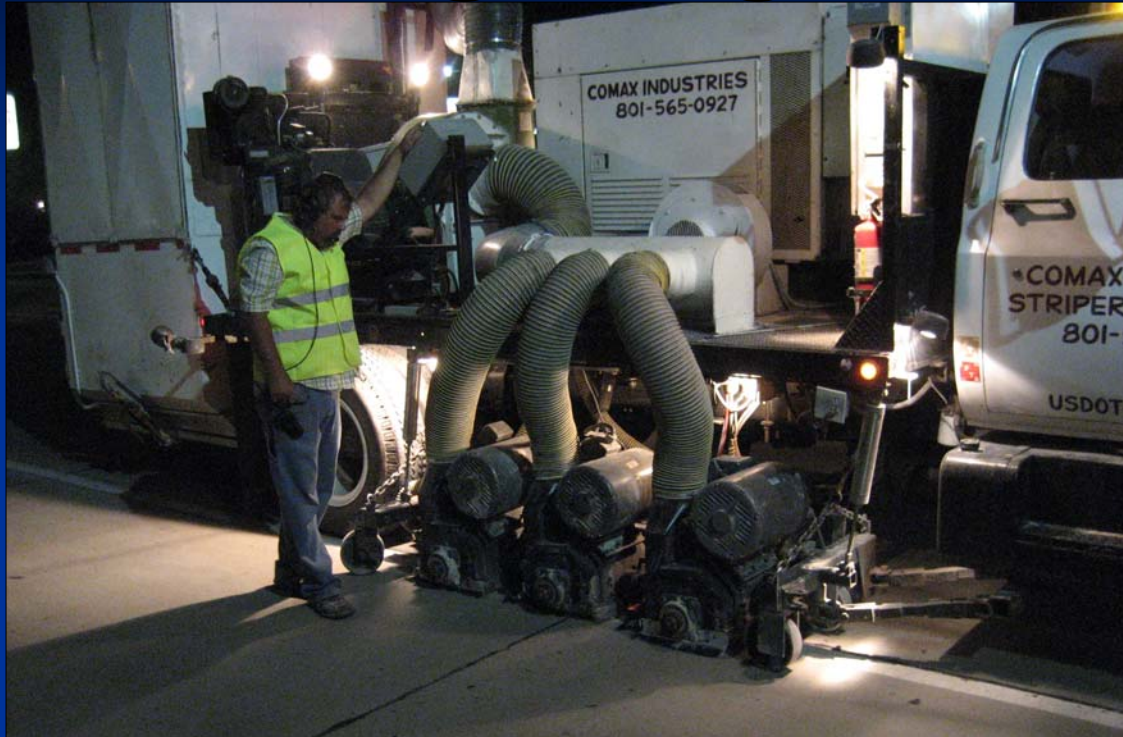
Grinding Long Lines

- 3 head, vacuum assisted, diamond grinder, dry
- 120 mils depth

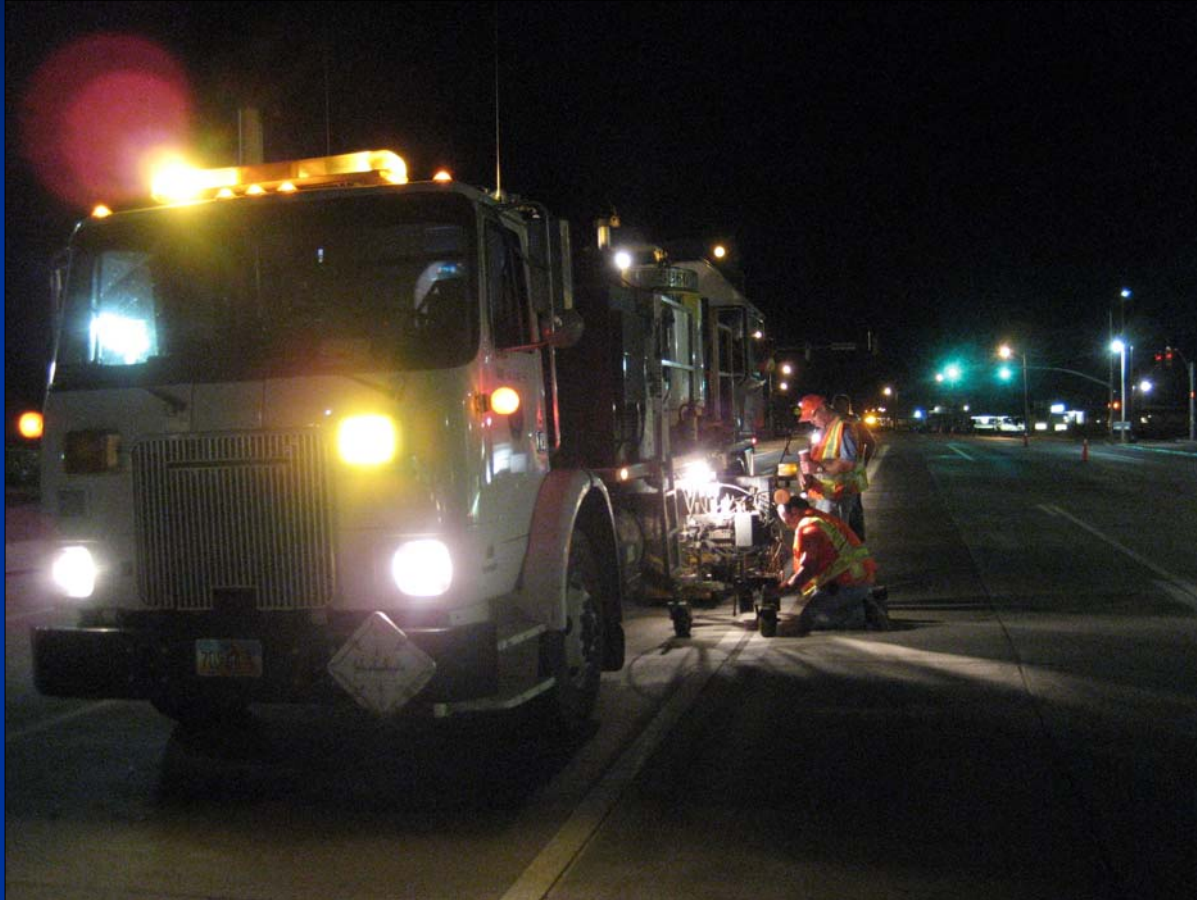
Installing Lines

- Price District paint crew worked at night when traffic was minimal

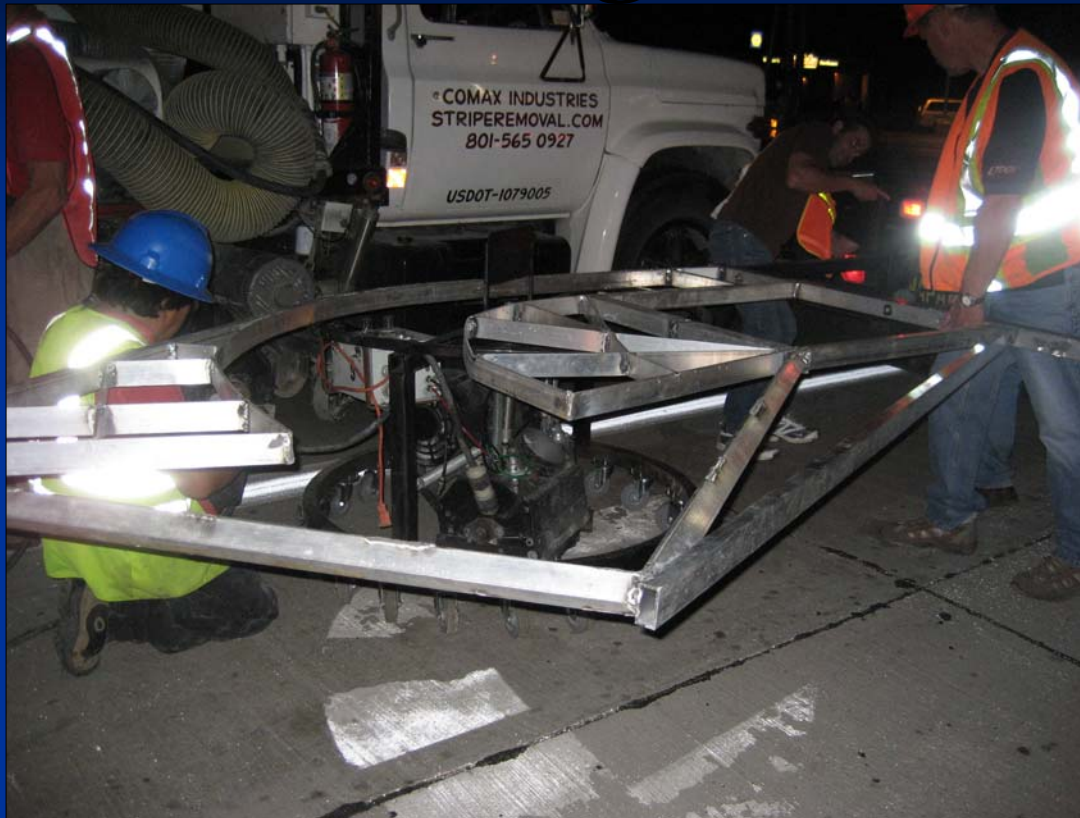
Grinding Arrows

- Template used & router-like grinder
- Only known template used for arrows, others grind a square
- Challenging to achieve consistent depth because of center crown

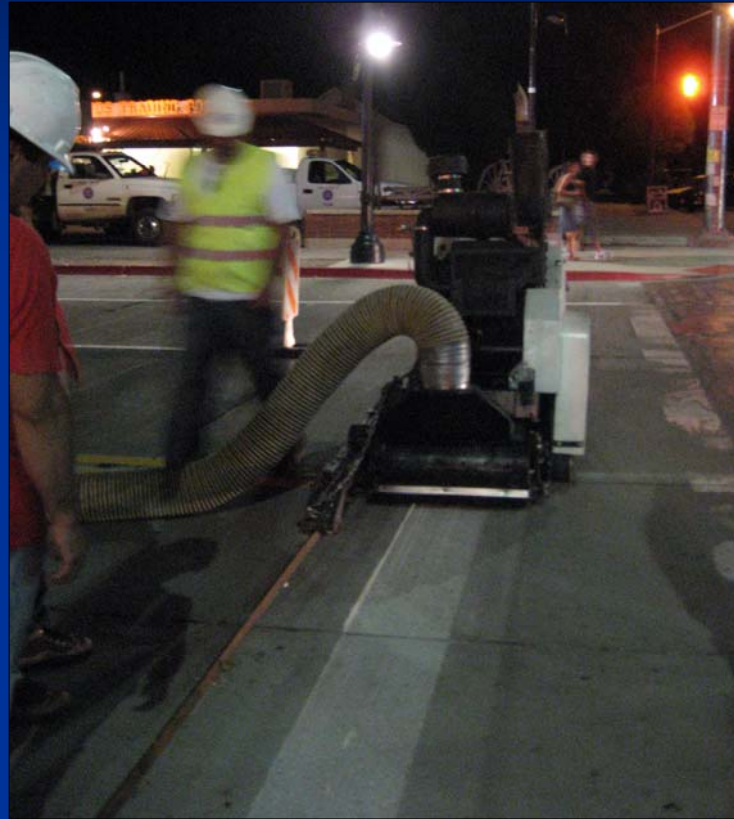
Grinding Crosswalks & Stop Bars

Experimented using different equipment depending on working room available

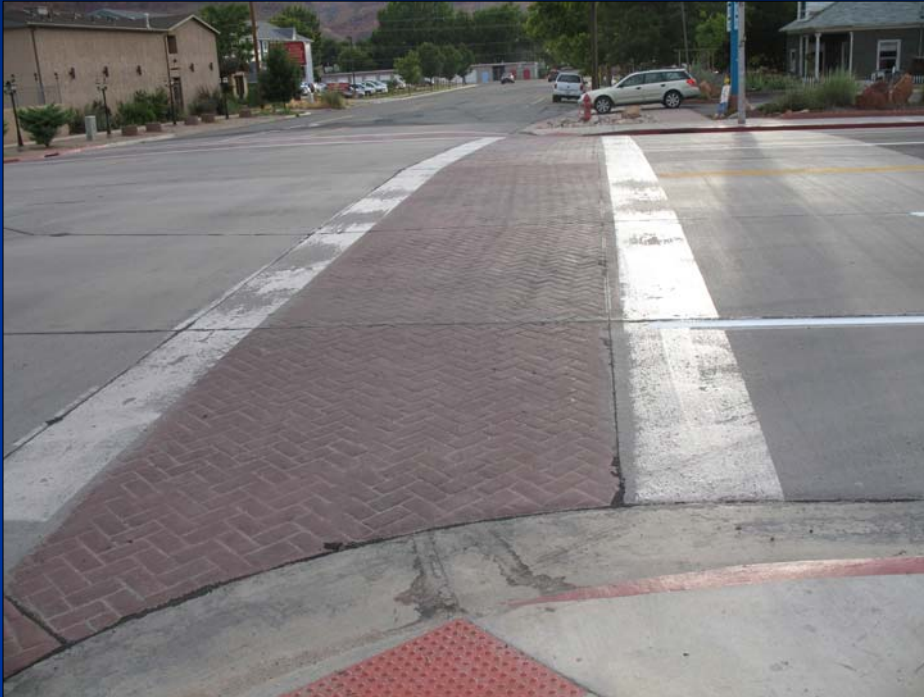
Aug. 2007, just before grinding

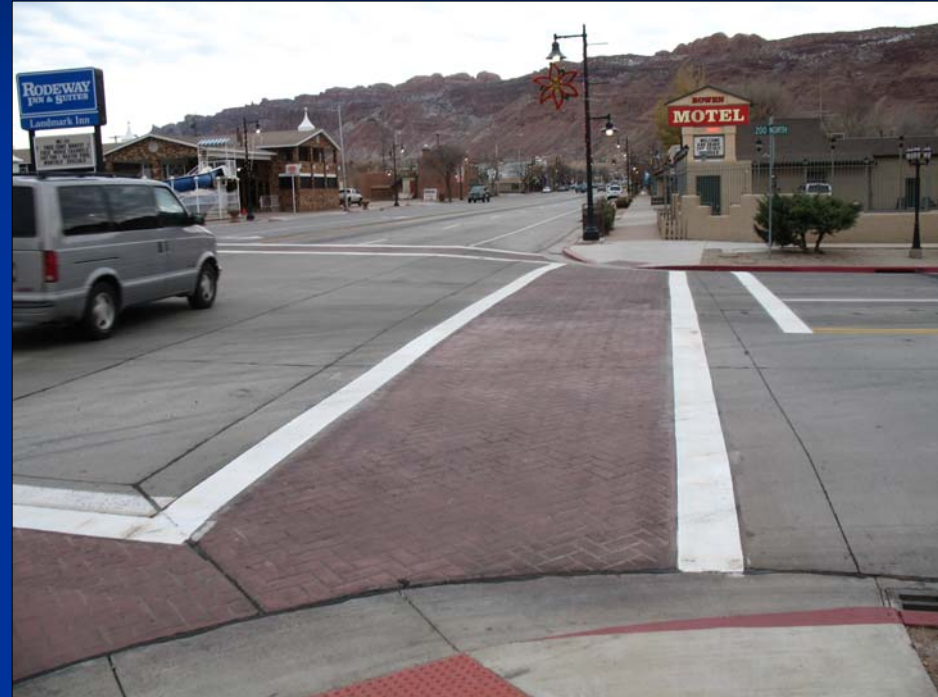
Nov. 2007, 2-1/2 months later

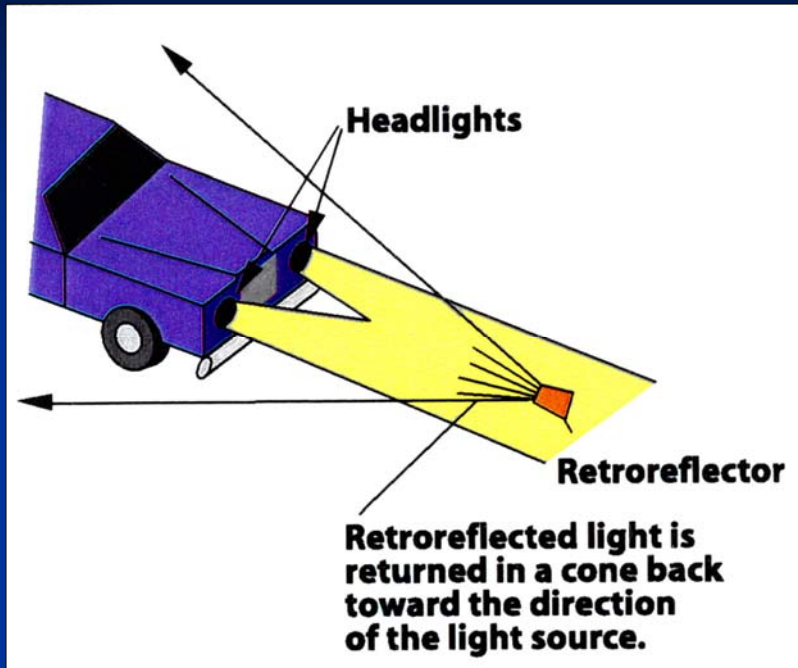
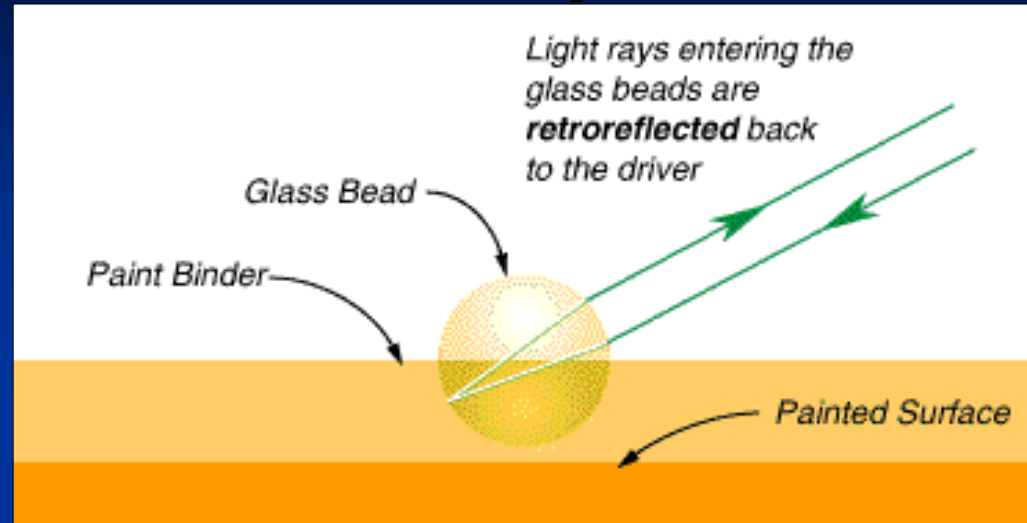
What is “retroreflectivity”?

- Ability to reflect light back to light source (R_L)
- R_L is measured in units of millicandelas per square meter per lux ($\text{mcd}/\text{m}^2/\text{lux}$)
- Generally minimum range is 120-80 for long lines

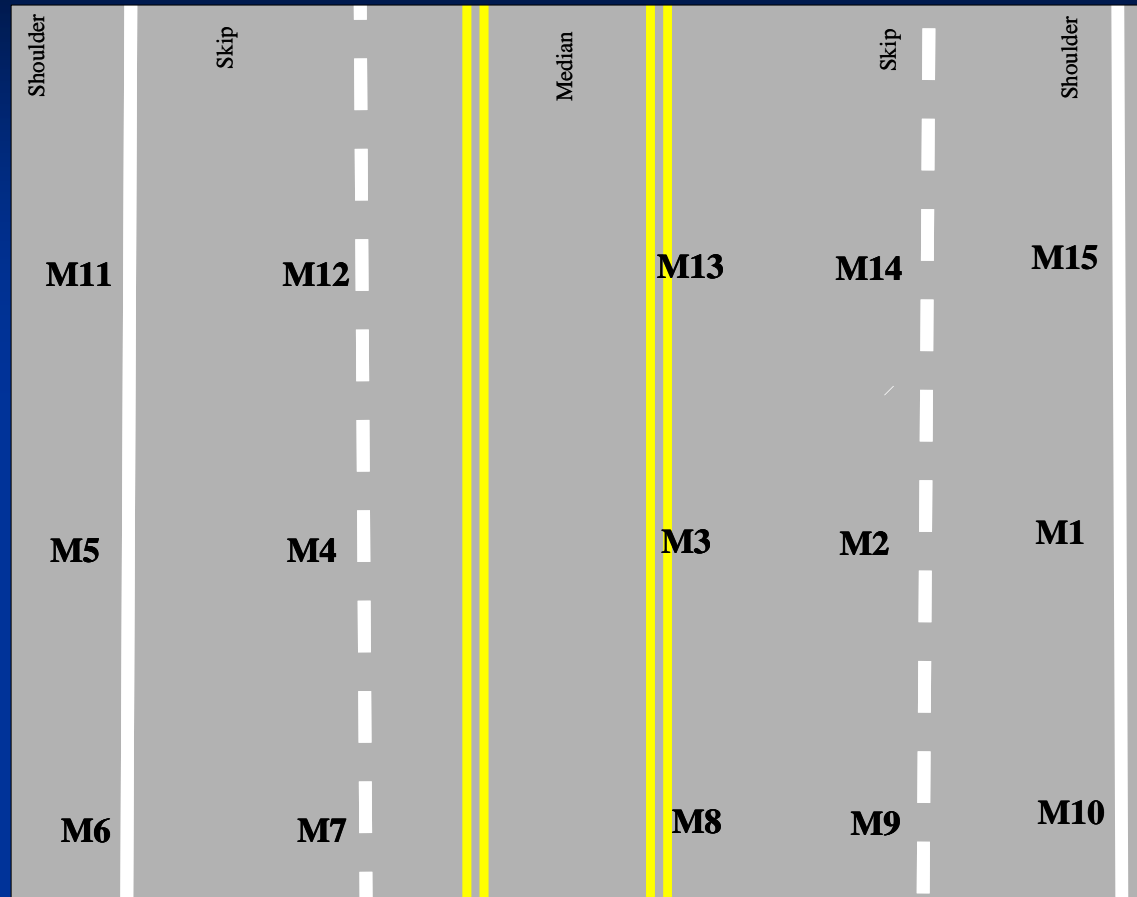
Midblock Readings

- Midblock readings taken at same location each time

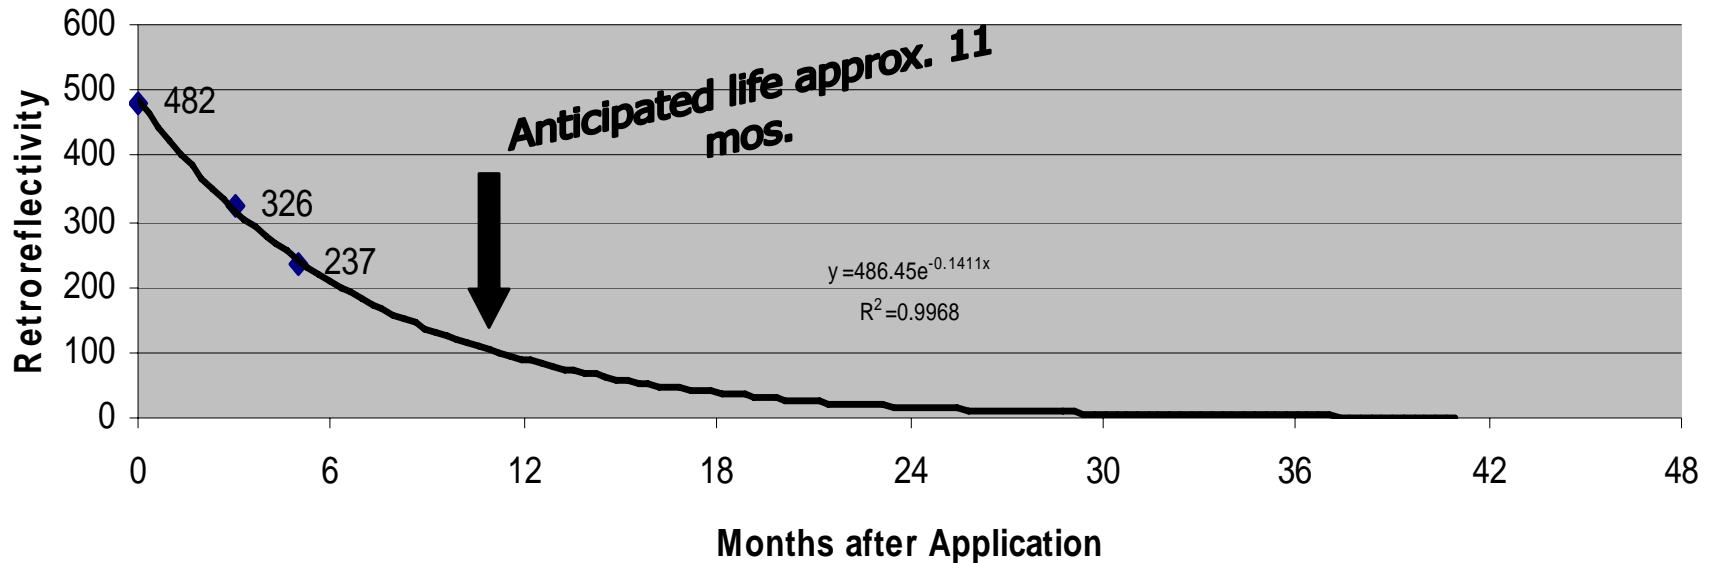
Moab Main Street Shoulders

Shoulders-Projected Life

- Take handheld retroreflectivity readings at select locations (ASTM E1710-5 with LTL 2000)
- Average retro readings for a given line and date
- Plot readings using decaying exponential trendline to predict failure at 100 mcd
- Calculate cost effectiveness and compare with durable markings

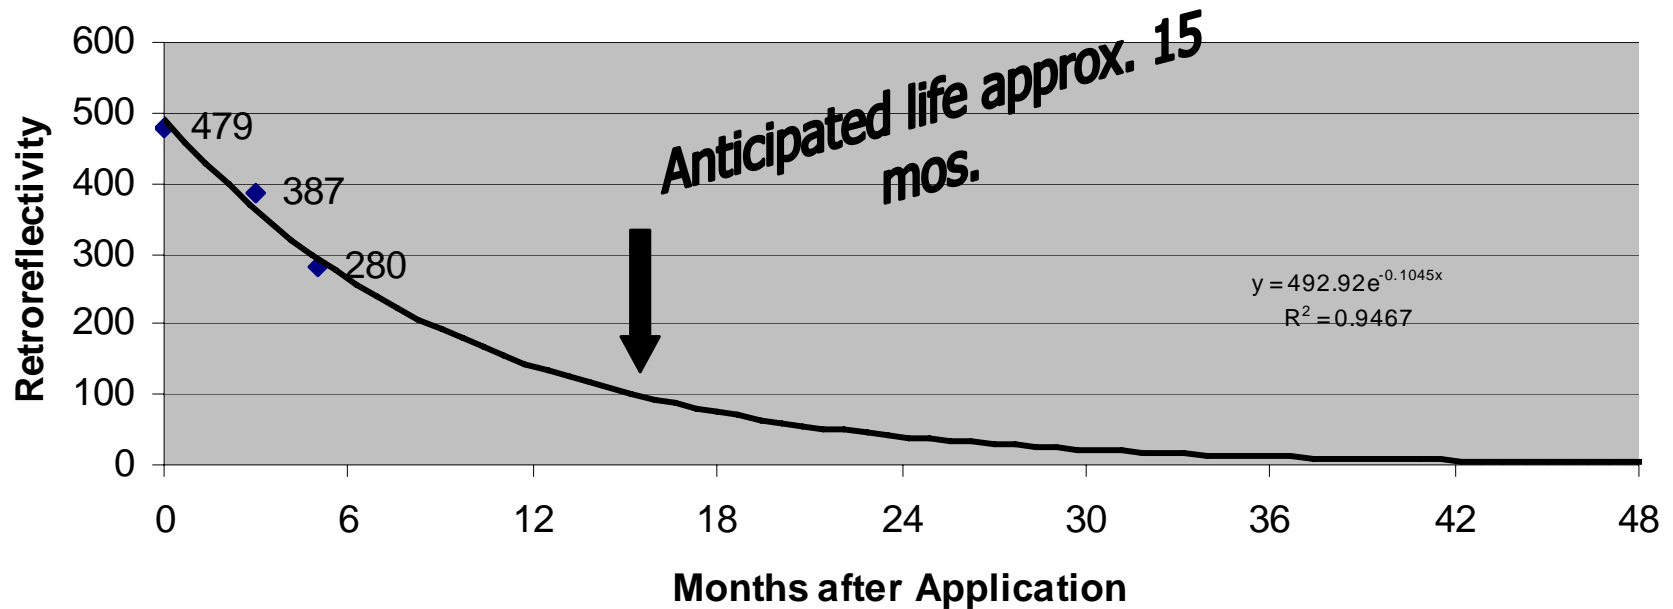
Moab Main Street Skips

Skips-Projected Life

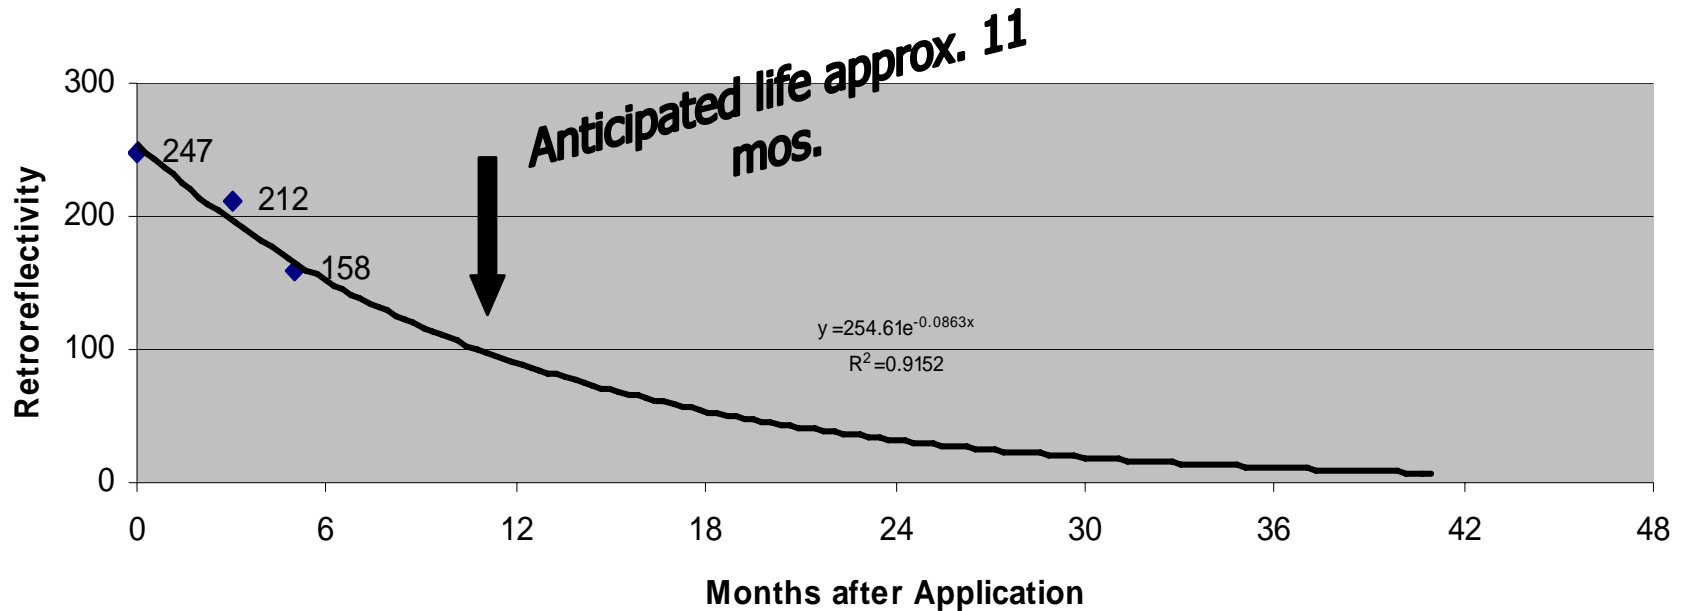
Moab Main Street Median

Median-Projected Life
